# MARIN

RE: *Phase I/ Phase II Environmental Site Investigation, Bixby's, Poultney, Vermont.*

Bixby's  
 Poultney, VT

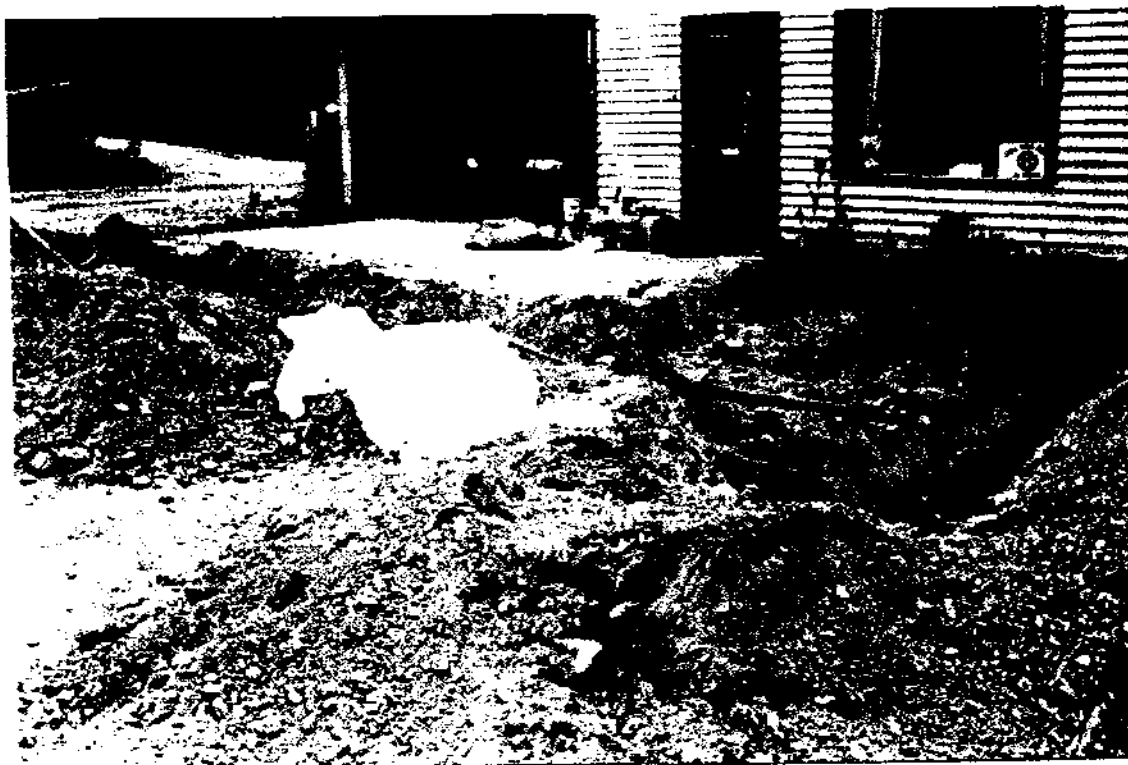
Photo 1: Bixby's, Poultney. Showing kerosene underground storage tank and pipeline excavation.

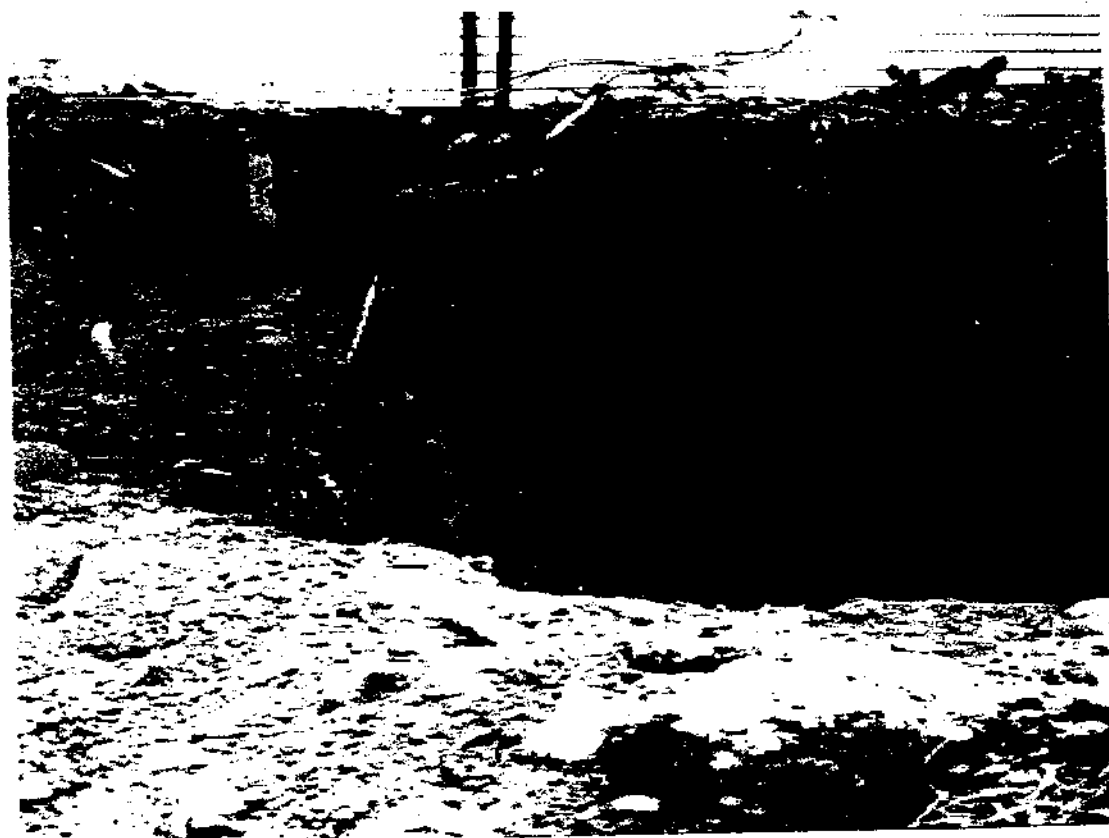
Photo 2: Bixby's, Poultney. Showing kerosene underground storage tank excavation with fill pipe and vent pipes for the kerosene and heating oil tanks.

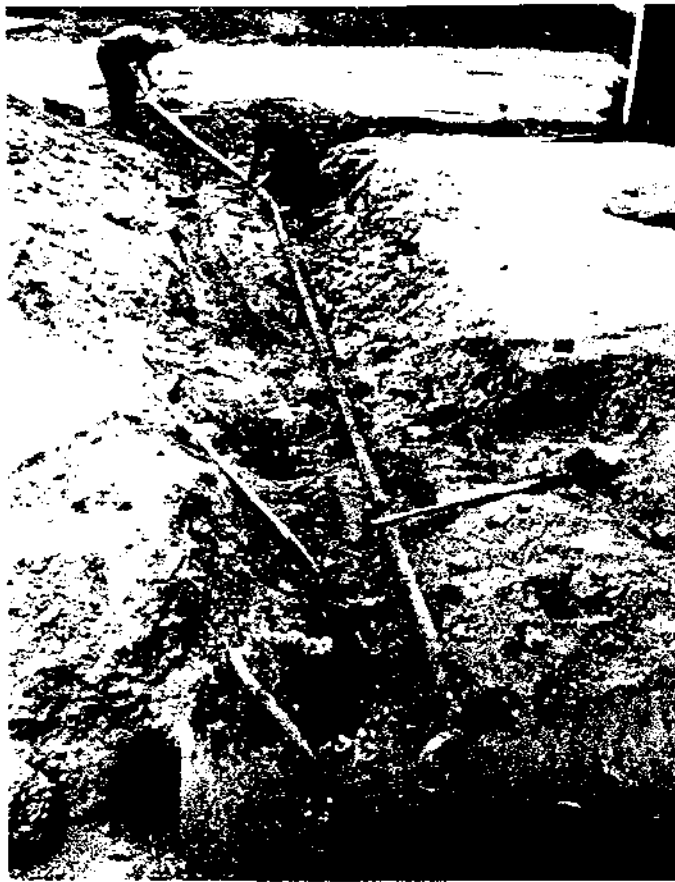
Photo 3: Bixby's, Poultney. Showing excavation of pipeline from kerosene tank toward closed dispenser island. Bentley Avenue in background.

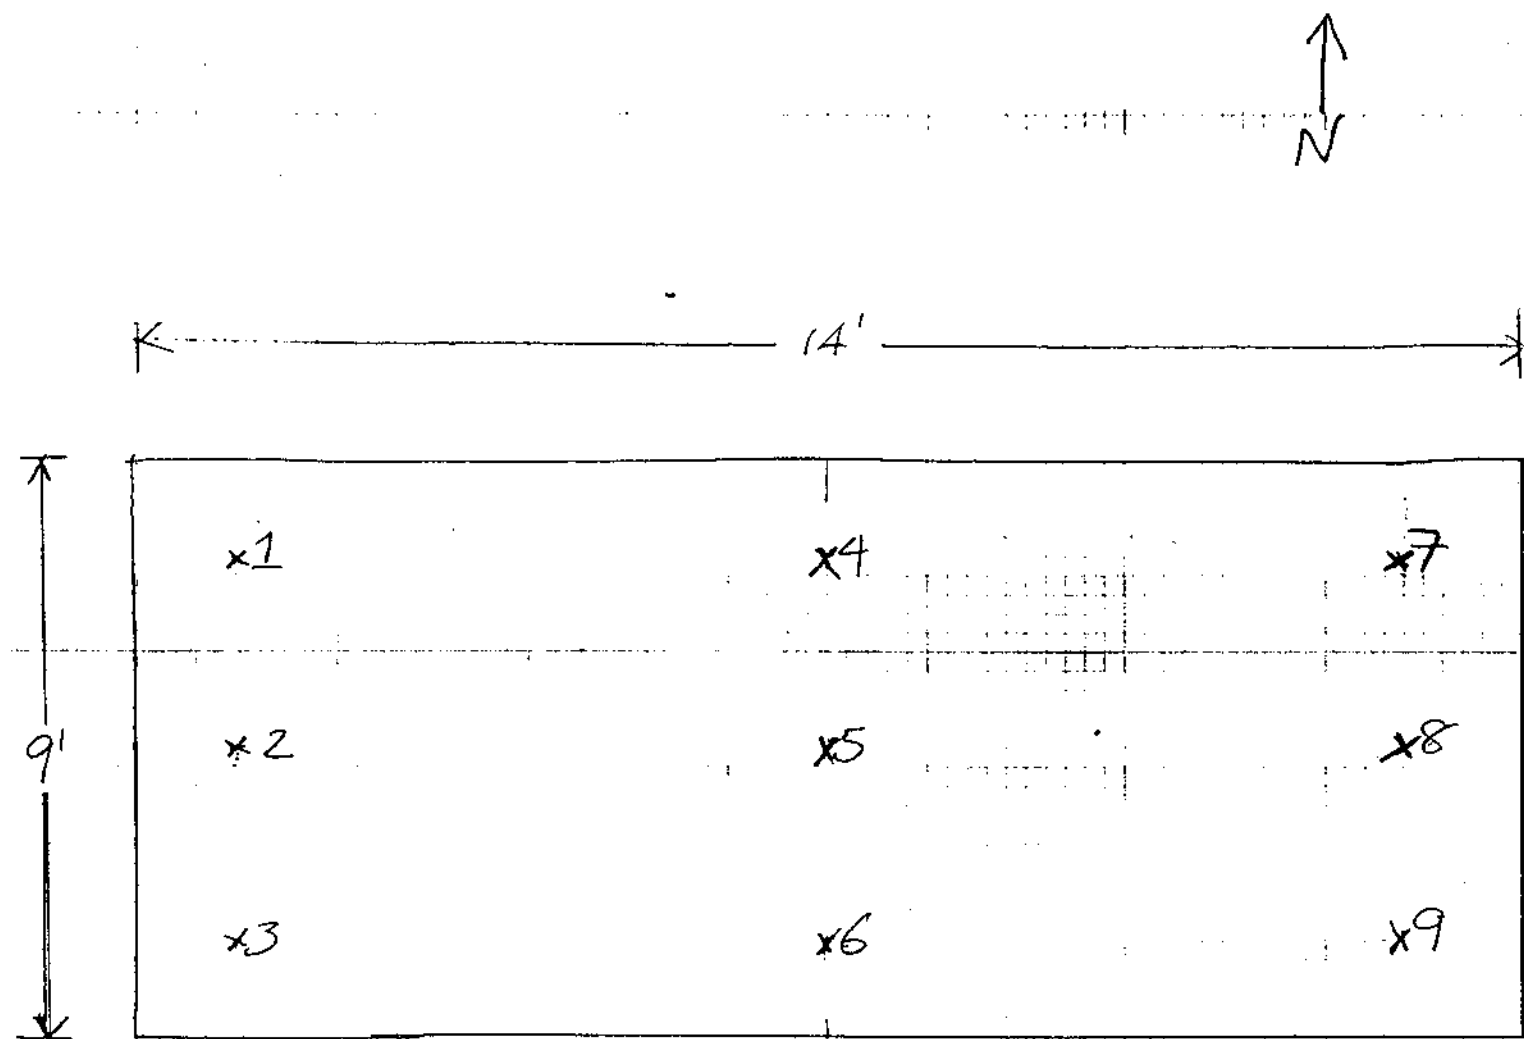
FIGURE 1. SOIL SAMPLING POINTS  
BIXBY'S PETROLEUM

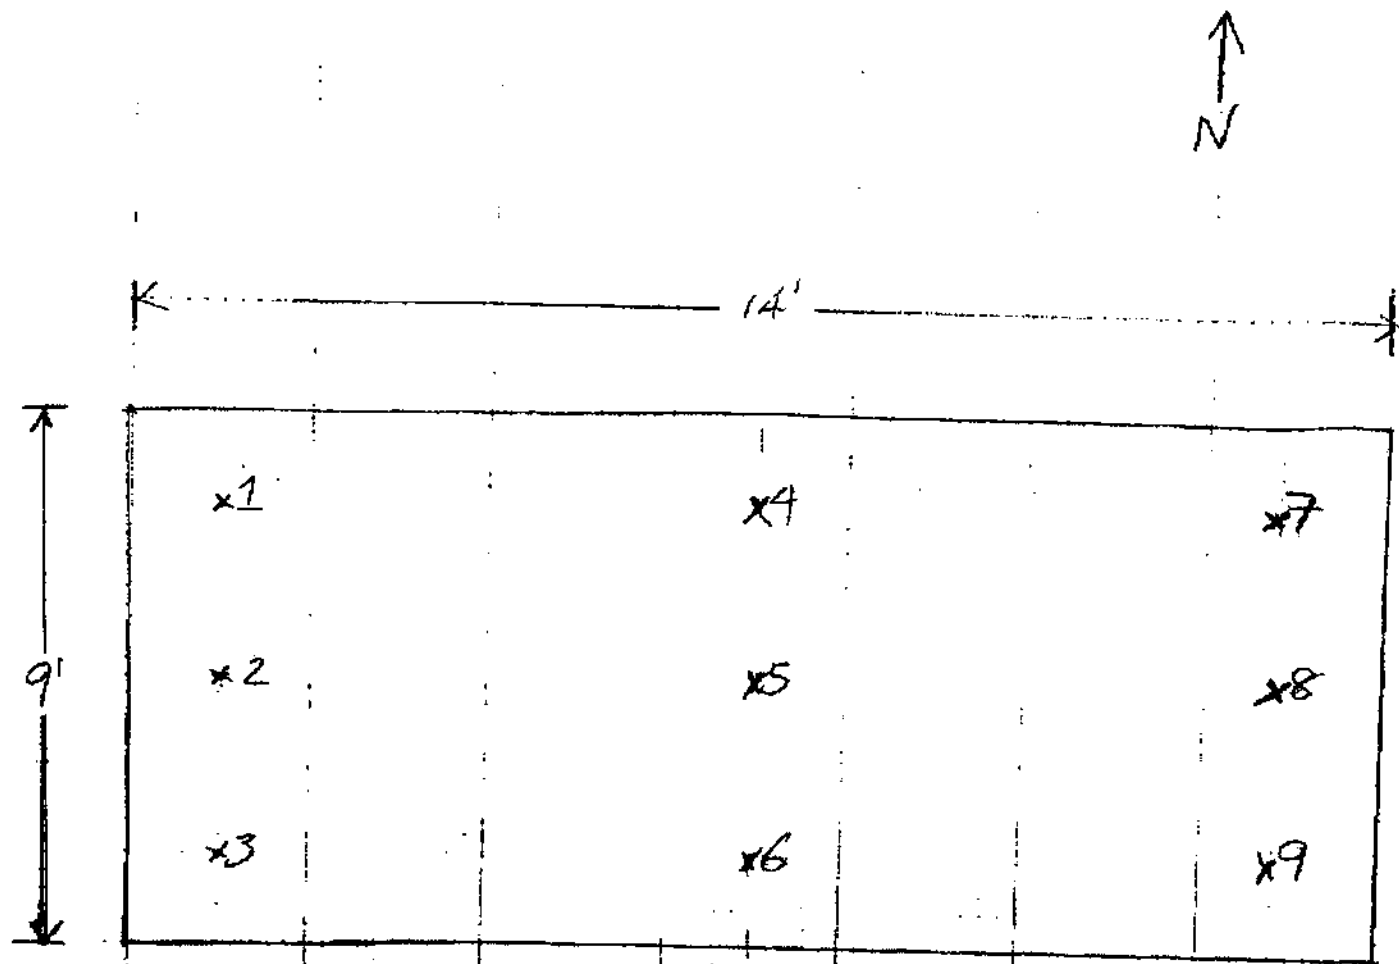
FIGURE 1. SOIL SAMPLING POINTS  
BIXBY'S PETROLEUM

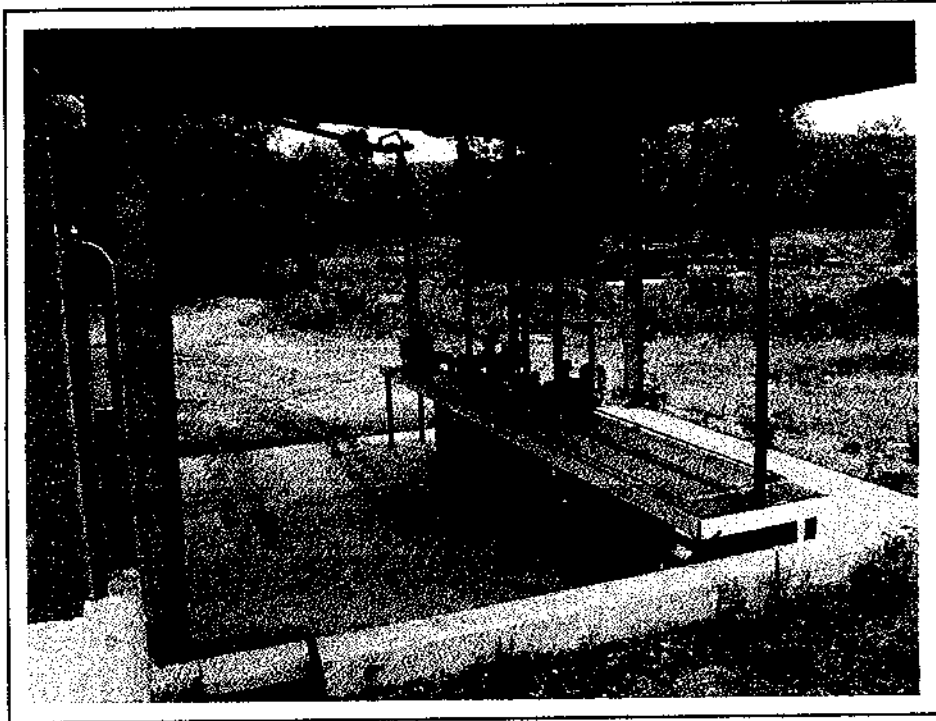
- Some soil staining was observed in the former AST storage area, no significant sheening was observed.
- With the exception of some petroleum staining observed on the concrete pad underlying the current delivery truck loading rack and transport unloading area, only limited petroleum staining was observed within the current bulk petroleum storage area.

Current Delivery Truck Loading Area  
View is Toward Intermittent Stream

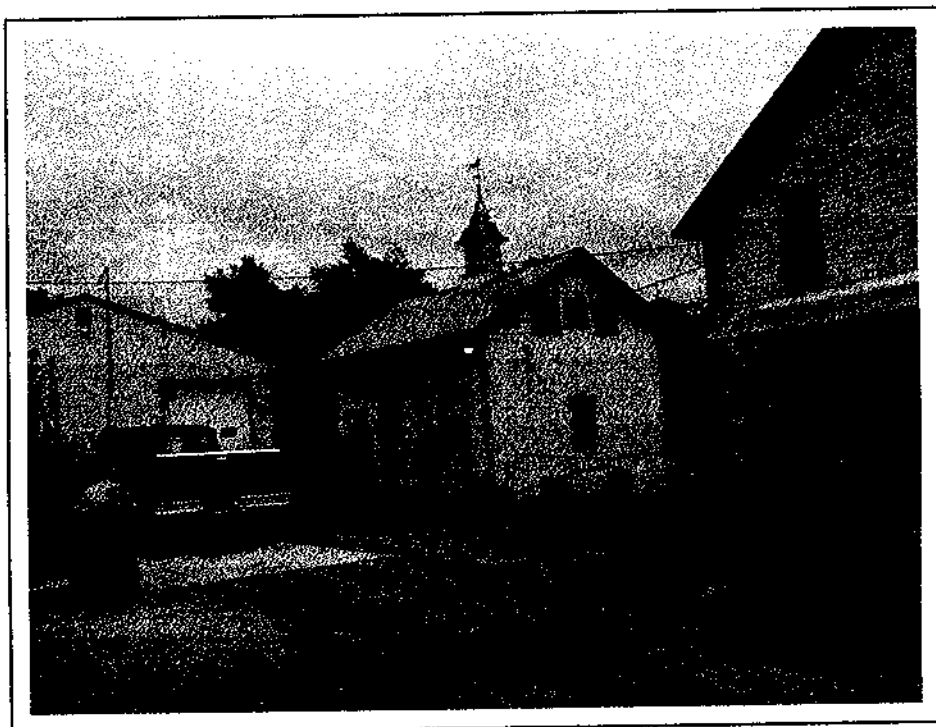
Maintenance Garage/Office Building, Storage Barns, and Fuel Dispensing Island  
(in northern portion of site)

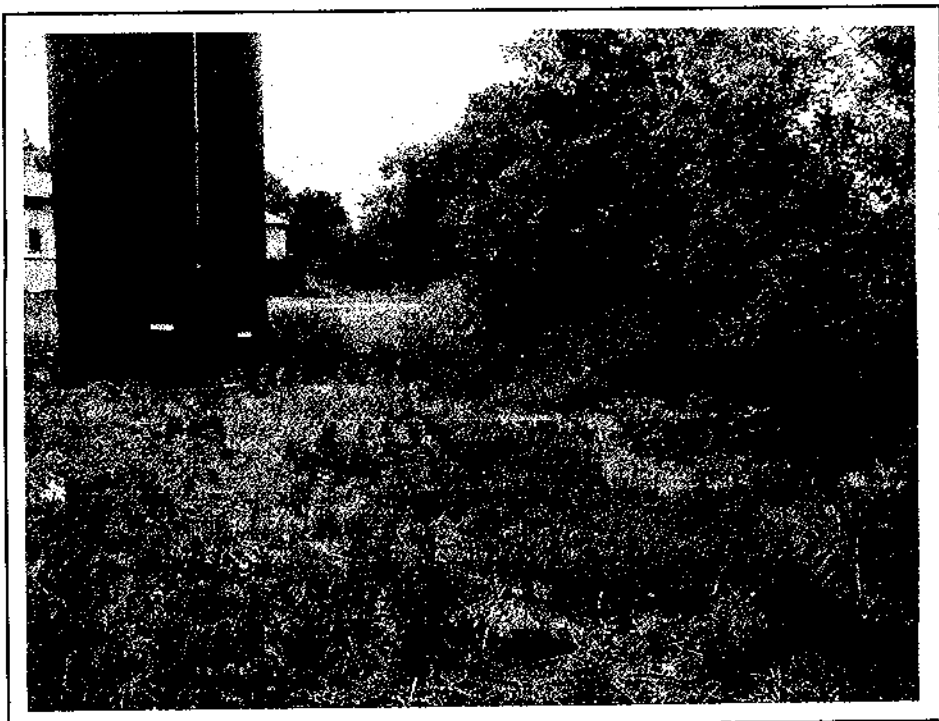
20,000-Gallon Diesel AST Remaining in Former AST Area

- 5 The 20,000-gallon diesel AST and associated piping should be purged of residual product and be removed from the source area to eliminate a potential ongoing source of free product. The product should be disposed in accordance with appropriate waste handling procedures.
- 6 The curtain drain system should be evaluated to ensure that current operations are being conducted using best management practices.
